**Flood Control Project Maintenance  
Levee Inspections**

**Fall 2019 Levee Maintenance Deficiency Summary Report**

**Sacramento River Basin**

**Sacramento Maintenance Yard Maintenance Area 0009**

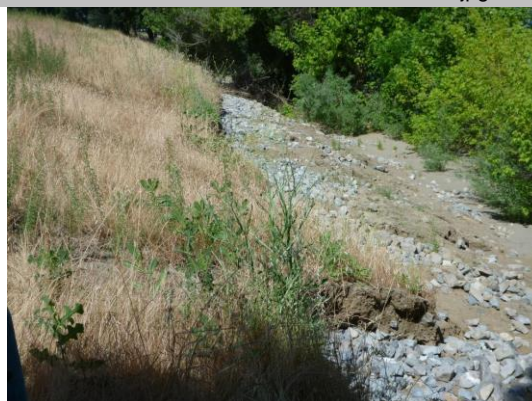
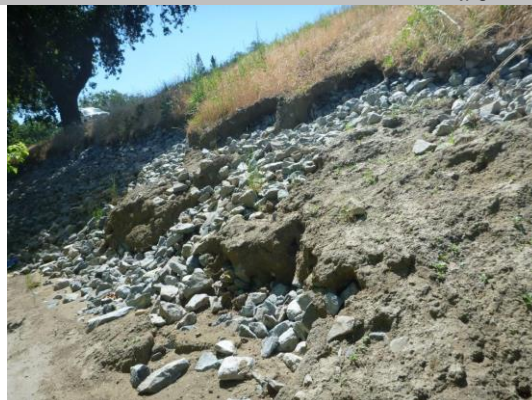
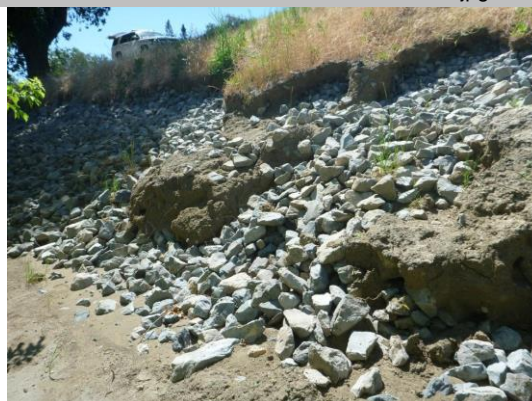
LM Start	2.57	Rating **	A/W	Issue No.	232
LM End	2.58	Issue Type +	Ma	Location *	
Category	Supplemental			GPS Latitude/Longitude	
				Start	End
Item	2017 Storm Damage			38.516444 °	38.516442 °
				-121.530639 °	-121.530677 °
DWR ID	LMA-65				
Comment Code					
Inspector Comment					
Levee Evaluation Comments					
Description:					
Site ID No:232					
Site Designation:LMA-65					
Repair Type: Erosion					
Rating: Area of Concern					
Field Date:6/2/2017					
Notes: riparian scrub vegetation along WS bank/bench.

LM Start	2.57	Rating **	A/W	Issue No.	232 (cont)	
LM End	2.58	Issue Type +	Ma	Location *		
Category	Supplemental			GPS Latitude/Longitude		
				Start	End	
Item	2017 Storm Damage			38.516444 °	38.516442 °	
				-121.530639 °	-121.530677 °	
DWR ID	LMA-65					
Comment Code						
Inspector Comment						
Levee Evaluation Comments						
Description:						
Site ID No:232						
Site Designation:LMA-65						
Repair Type: Erosion						
Rating: Area of Concern						
Field Date:6/2/2017						
Notes: riparian scrub vegetation along WS bank/bench.

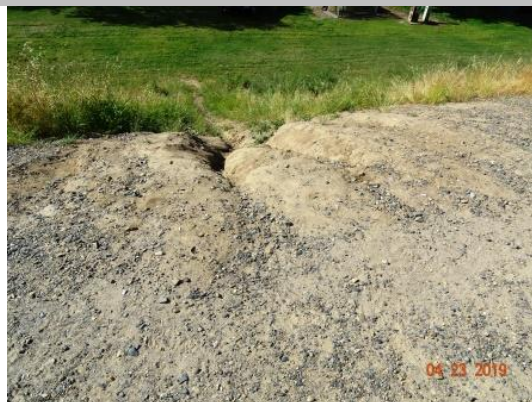
Photo 1 of 1 : FA\_2019\_MA0009\_201\_329\_20190904\_00229.jpg

LM Start	2.58	Rating **	A/W	Issue No.	329
LM End	2.58	Issue Type +	Ma	Location *	LS
Category	Earthen Levee			GPS Latitude/Longitude	
				Start	End
Item	Erosion / Bank Caving			38.516460 °	38.516460 °
				-121.530673 °	-121.530673 °
DWR ID	DWR_MA0009_01_f_2017_329				
Comment Code					
E1 : Note and monitor erosion site.					
Inspector Comment					
Monitor runoff erosion at landside hinge point.

View of runoff erosion at landside hinge point. Spring 2019

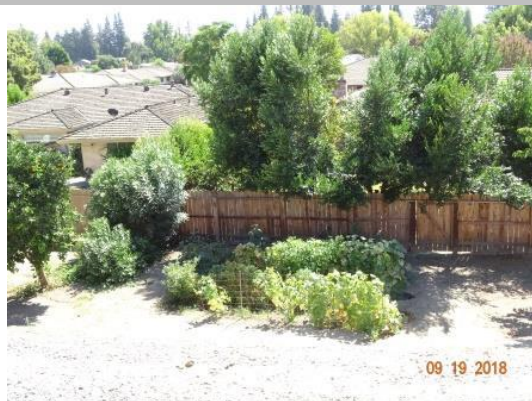
Photo 1 of 2 : FA\_2019\_MA0009\_201\_235\_20190904\_00154.jpg

LM Start	2.73	Rating **	M	Issue No.	235
LM End	2.73	Issue Type +	En	Location *	LS
Category	Earthen Levee			GPS Latitude/Longitude	
				Start	End
Item	Vegetation			38.516236 °	38.516236 °
				-121.533581 °	-121.533581 °
DWR ID	DWR_MA0009_01_s_2018_235				
Comment Code					
V6 : Landscaping					
Inspector Comment					
Landowner has dug rows for a garden within 10' of the landside toe. Garden lattices block access, and fruit trees are not permitted within levee easement.

View of growing garden with lattices near landside toe. Fall 2018

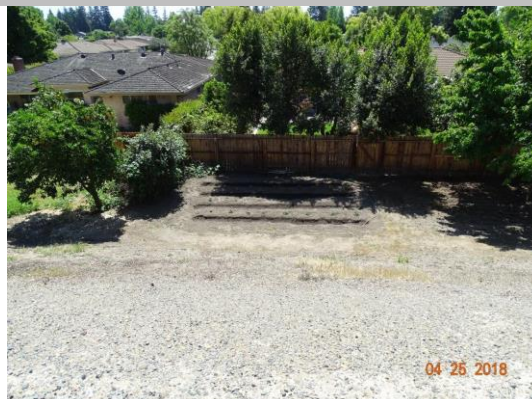
Photo 2 of 2 : FA\_2019\_MA0009\_201\_235\_20190904\_00155.jpg

View of garden rows near landside toe. Spring 2018.

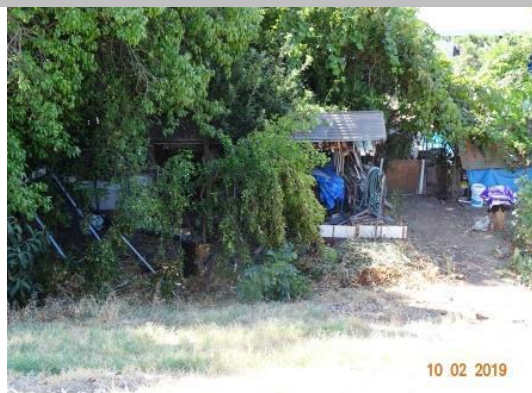
Photo 1 of 1 : FA\_2019\_MA0009\_201\_338\_20191008\_00513.jpg

LM Start	2.82	Rating **	M	Issue No.	338
LM End	2.82	Issue Type +	En	Location *	LS
Category	Earthen Levee			GPS Latitude/Longitude	
				Start	End
Item	Encroachments			38.516144°	38.516144°
				-121.535235°	-121.535235°
DWR ID	DWR_MA0009_01_f_2017_338				
Comment Code					
MA : Material					
Inspector Comment					
Landowner needs to move shed and clear landscaping materials from at least 10' away from the levee toe.

View of shed and landscaping materials within 10' of the levee toe. Fall 2019

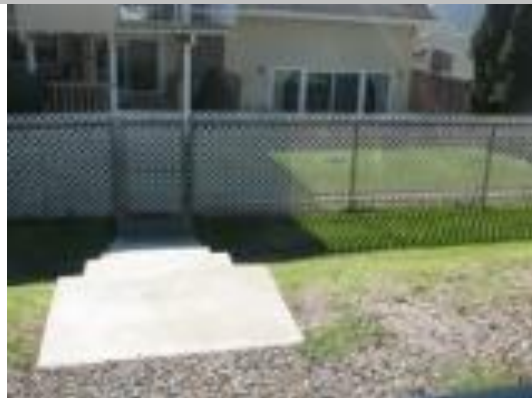
Photo 1 of 1 : FA\_2019\_MA0009\_201\_51\_20190904\_00019.jpg

LM Start	2.94	Rating **	M	Issue No.	51
LM End	2.94	Issue Type +	En	Location *	LS
Category	Earthen Levee			GPS Latitude/Longitude	
				Start	End
Item	Encroachments			38.516025 °	38.516025 °
				-121.537391 °	-121.537391 °
DWR ID	DWR_MA0009_01_s_2017_51				
Comment Code					
ST : Stairway					
Inspector Comment

Steps and landscaping in easement. Fall 2012

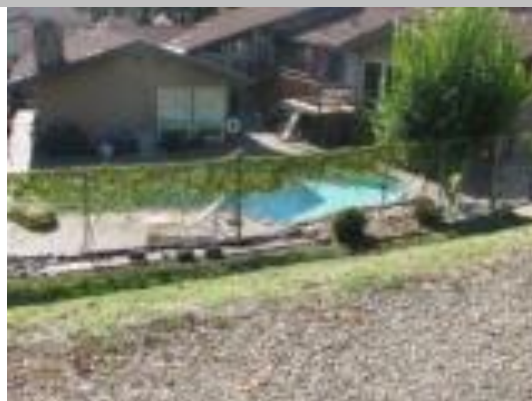
Photo 1 of 1 : FA\_2019\_MA0009\_201\_1254\_20190904\_00306.jpg

LM Start	2.97	Rating **	M	Issue No.	1254
LM End	2.97	Issue Type +	En	Location *	LS
Category	Earthen Levee			GPS Latitude/Longitude	
				Start	End
Item	Encroachments			38.515971 °	38.515971 °
				-121.537862 °	-121.537862 °
DWR ID	DWR_MA0009_01_s_2012_1254				
Comment Code					
PL : Pool					
Inspector Comment					
The swimming pool does not appear to be authorized.

Pool and retaining wall in the easement. Fall 2012

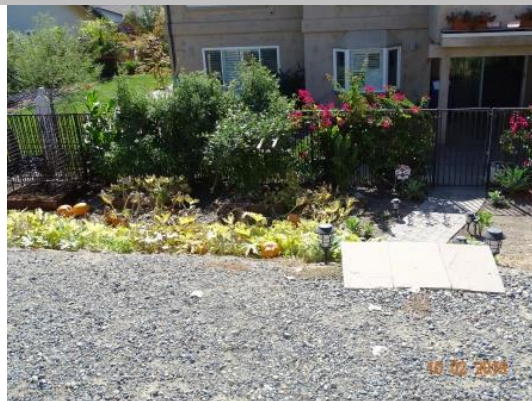
Photo 1 of 1 : FA\_2019\_MA0009\_201\_54\_20191008\_00515.jpg

LM Start	2.99	Rating **	M	Issue No.	54
LM End	2.99	Issue Type +	En	Location *	LS
Category	Earthen Levee			GPS Latitude/Longitude	
				Start	End
Item	Encroachments			38.515930 °	38.515930 °
				-121.538303 °	-121.538303 °
DWR ID	DWR_MA0009_01_f_2019_54				
Comment Code					
CR : Crops					
Inspector Comment					
The homeowner planted a pumpkin patch on the levee easement.

View of pumpkin patch planted at the levee toe. Fall 2019

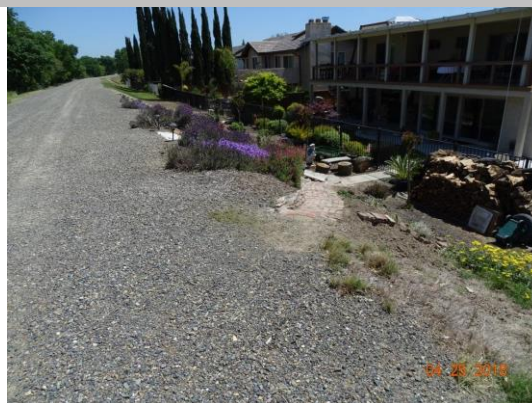
Photo 1 of 1 : FA\_2019\_MA0009\_201\_35\_20190904\_00011.jpg

LM Start	3.01	Rating **	M	Issue No.	35
LM End	3.02	Issue Type +	En	Location *	LS
Category	Earthen Levee			GPS Latitude/Longitude	
				Start	End
Item	Vegetation			38.515860 °	38.515821 °
				-121.538635 °	-121.538895 °
DWR ID	DWR_MA0009_01_f _ 2017_35				
Comment Code					
V6 : Landscaping					
Inspector Comment					
There is a footpath and multiple planter boxes at landside toe.

View of vegetation and footpath on the landside slope. Spring 2018.

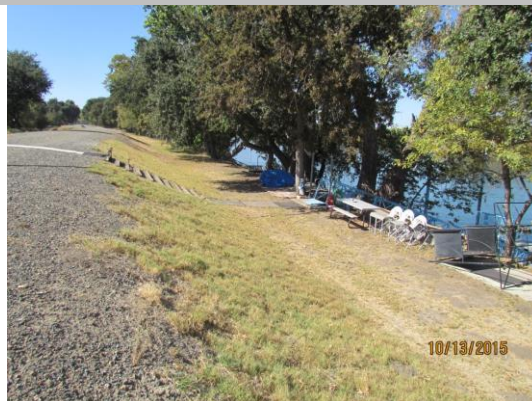
Photo 1 of 1 : FA\_2019\_MA0009\_201\_1768\_20190904\_00307.jpg

LM Start	3.01	Rating **	M	Issue No.	1768
LM End	3.01	Issue Type +	En	Location *	WS
Category	Earthen Levee			GPS Latitude/Longitude	
				Start	End
Item	Encroachments			38.515841 °	38.515841 °
				-121.538710 °	-121.538710 °
DWR ID	DWR_MA0009_01_s _ 2017_1768				
Comment Code					
EQ : Equipment					
Inspector Comment					
Landowner equipment on waterside berm needs to be moved.

View of the equipment on the berm of the waterward side looking downstream. Fall 2015.

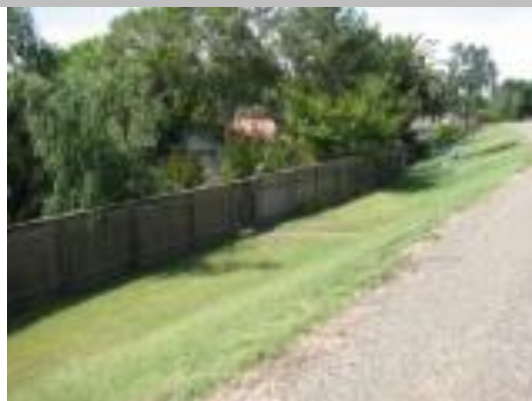
Photo 1 of 1 : FA\_2019\_MA0009\_201\_58\_20190904\_00023.jpg

LM Start	3.07	Rating **	U	Issue No.	58
LM End	3.08	Issue Type +	En	Location *	LS
Category	Earthen Levee			GPS Latitude/Longitude	
				Start	End
Item	Encroachments			38.515655 °	38.515598 °
				-121.539722 °	-121.539976 °
DWR ID	DWR_MA0009_01_s_2012_58				
Comment Code					
FE : Fence					
Inspector Comment					
The wooden fence does not appear to be authorized.

Several homes have solid fences and make it hard to see.

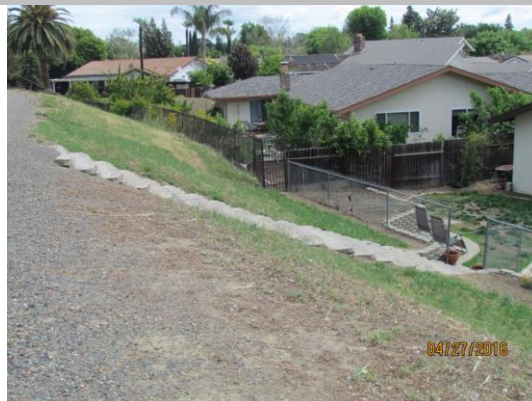
Photo 1 of 1 : FA\_2019\_MA0009\_201\_62\_20190904\_00024.jpg

LM Start	3.12	Rating **	M	Issue No.	62
LM End	3.12	Issue Type +	En	Location *	LS
Category	Earthen Levee			GPS Latitude/Longitude	
				Start	End
Item	Encroachments			38.515481 °	38.515481 °
				-121.540605 °	-121.540605 °
DWR ID	DWR_MA0009_01_s_2012_62				
Comment Code					
RW : Retaining Wall					
Inspector Comment					
The concrete steps and retaining wall do not appear to be authorized.

View of the steps on the slope and the retaining wall at the toe of the levee on the landward side looking upstream. Spring 2016.

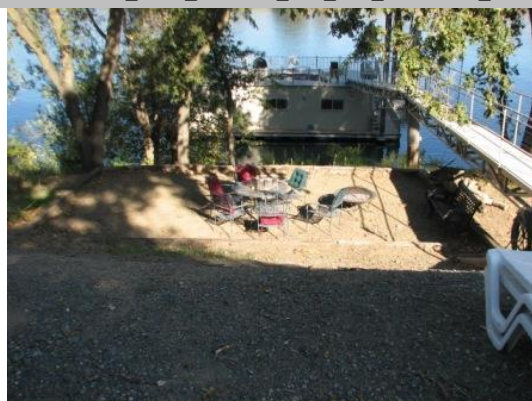
Photo 1 of 1 : FA\_2019\_MA0009\_201\_165\_20190904\_00093.jpg

LM Start	3.18	Rating **	M	Issue No.	165
LM End	3.18	Issue Type +	En	Location *	WS
Category	Earthen Levee			GPS Latitude/Longitude	
				Start	End
Item	Encroachments			38.515257 °	38.515257 °
				-121.541667 °	-121.541667 °
DWR ID	DWR_MA0009_01_s_2013_165				
Comment Code					
EQ : Equipment					
Inspector Comment					
Decomposed granite on the berm of the watereward side of the levee.

A decomposed granite patio is on the berm. Fall 2013

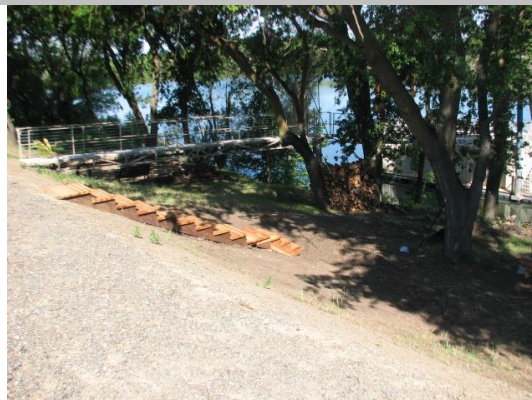
Photo 1 of 3 : FA\_2019\_MA0009\_201\_299\_20190904\_00202.jpg

LM Start	3.18	Rating **	M	Issue No.	299
LM End	3.18	Issue Type +	En	Location *	WS
Category	Earthen Levee			GPS Latitude/Longitude	
				Start	End
Item	Encroachments			38.515255 °	38.515255 °
				-121.541672 °	-121.541672 °
DWR ID	DWR_MA0009_01_s_2014_299				
Comment Code					
ST : Stairway					
Inspector Comment					
Steps, decking plus firewood need a permit. Stairway does not have permit but does not inhibit emergency operations.

New steps on the waterside slope. Spring 2014

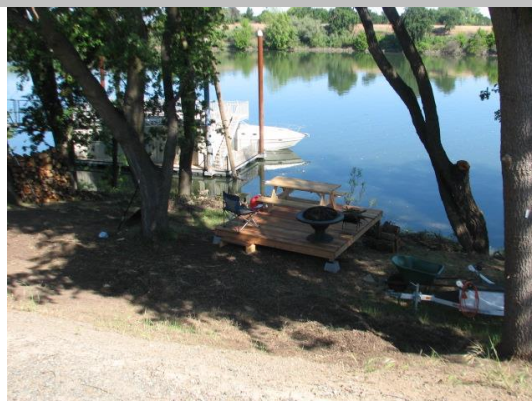
Photo 2 of 3 : FA\_2019\_MA0009\_201\_299\_20190904\_00203.jpg

A new deck has been added to the waterside berm. Spring 2014

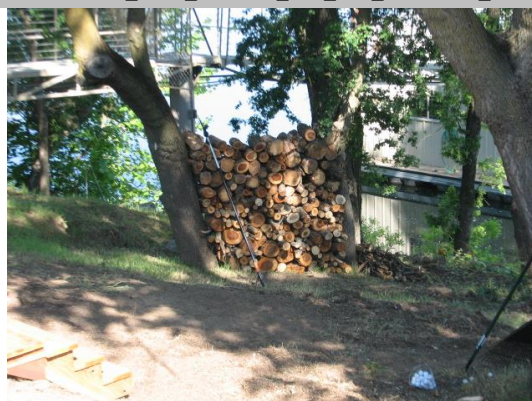
Photo 3 of 3 : FA\_2019\_MA0009\_201\_299\_20190904\_00204.jpg

A large stack of firewood on the waterside berm. Spring 2014

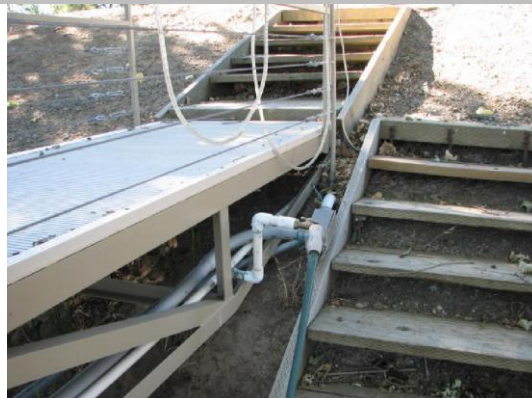
Photo 1 of 2 : UCIP\_FA\_2019\_5860\_8946.jpg

LM Start	3.19	Rating **	M	Issue No.	1787
LM End	3.19	Issue Type +	En	Location *	
Category	Supplemental			GPS Latitude/Longitude	
				Start	End
Item	DRAFT DWR UCIP Field Study			38.515210 °	38.515210 °
				-121.541840 °	-121.541840 °
DWR ID	18909				
Comment Code					
Inspector Comment					
DS_ID:18909 FS_ID:5860 EP_NO: N/A Repair Type: Non-Urgent Crossing Status: Found UCIP Comments: No permit identified for this crossing. This pipe was not part of the upgrade to the pier/walkway under Permit No. 17904. Nor was it part of the pier before the upgrade. FIELD_STRUCT_DESC: 1-inch polyvinyl chloride (PVC) water line through the levee, 1.5 feet below the crown. Hose bib attached to downstream side of boat ramp/pier, 50 feet upstream from pipe crossing. FS Date: 6/20/2012 10:14:00 AM

Pipes visible on downstream side of pier walkway.

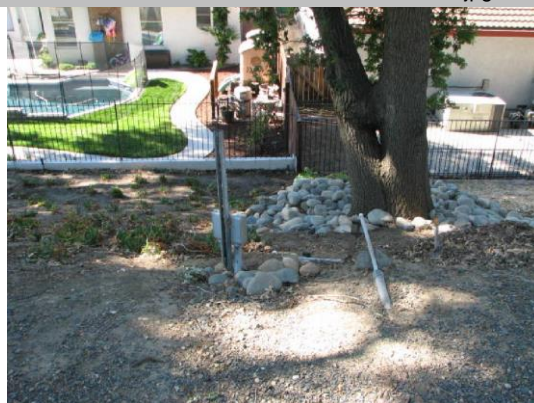
Photo 1 of 2 : UCIP\_FA\_2019\_5856\_8938.jpg

LM Start	3.19	Rating **	M	Issue No.	1788
LM End	3.19	Issue Type +	En	Location *	
Category	Supplemental			GPS Latitude/Longitude	
				Start	End
Item	DRAFT DWR UCIP Field Study			38.515210 °	38.515210 °
				-121.541840 °	-121.541840 °
DWR ID	18910				
Comment Code					
Inspector Comment					
DS_ID:18910 FS_ID:5856 EP_NO: N/A Repair Type: Non-Urgent Crossing Status: Found UCIP Comments: No permit identified for this crossing. FIELD_STRUCT_DESC: 2-inch galvanized steel electrical conduit through the levee, 0.5 feet below the crown. 0.75-inch polyvinyl chloride (PVC) electrical conduit running through it. FS Date: 6/20/2012 10:18:37 AM

Galvanized steel pipe with pvc electrical conduit running through it, LS shoulder 50-feet downstream from pier/ramp.

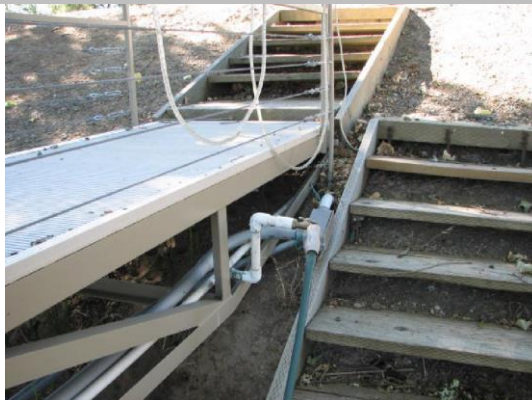
Photo 1 of 2 : UCIP\_FA\_2019\_5854\_8934.jpg

LM Start	3.19	Rating **	M	Issue No.	1789	
LM End	3.19	Issue Type +	En	Location *		
Category	Supplemental			GPS Latitude/Longitude		
				Start	End	
Item	DRAFT DWR UCIP Field Study			38.515230 °	38.515230 °	
				-121.541850 °	-121.541850 °	
DWR ID	18908					
Comment Code						
Inspector Comment						
DS_ID:18908						
FS_ID:5854						
EP_NO: N/A						
Repair Type: Non-Urgent						
Crossing Status: Found						
UCIP Comments: No permit identified for this crossing. Pipes were not part of permit for upgrade to pier (PN: 17904) nor were they apart of the existing pier previous to this permit.						
FIELD_STRUCT_DESC: 1.25-inch polyvinyl chloride (PVC) electrical conduit through the levee, 1.5 feet below the crown. Electrical box mounted to post on the landside (LS) shoulder.						
FS Date: 6/20/2012 10:02:01 AM

Pipes at downstream side of walkway/pier on WS slope.

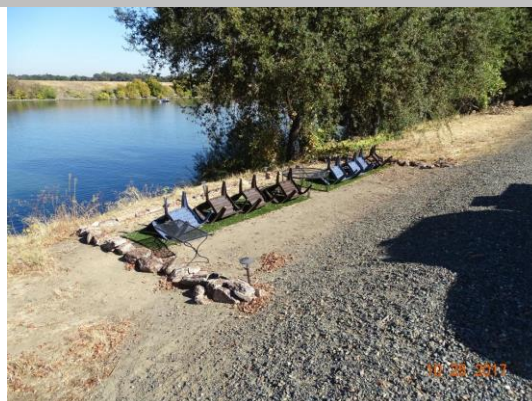
Photo 1 of 1 : FA\_2019\_MA0009\_201\_347\_20190904\_00250.jpg

LM Start	3.25	Rating **	M	Issue No.	347
LM End	3.25	Issue Type +	En	Location *	WS
Category	Earthen Levee			GPS Latitude/Longitude	
				Start	End
Item	Encroachments			38.514947 °	38.514947 °
				-121.543003 °	-121.543003 °
DWR ID	DWR_MA0009_01_f_2017_347				
Comment Code					
DE : Debris					
Inspector Comment					
Chairs, table, and rocks were placed on waterside berm.

View of chairs, table, and rocks on waterside berm. Fall 2017.

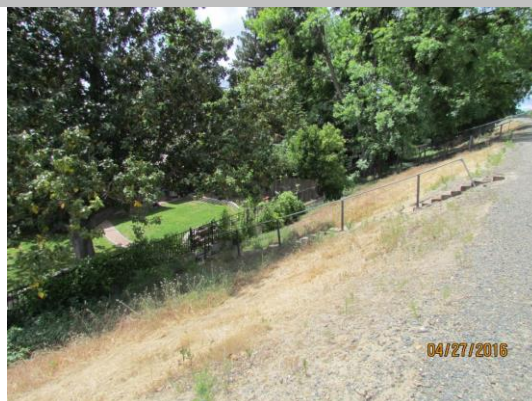
Photo 1 of 2 : FA\_2019\_MA0009\_201\_70\_20190904\_00027.jpg

LM Start	3.27	Rating **	M	Issue No.	70
LM End	3.28	Issue Type +	En	Location *	LS
Category	Earthen Levee			GPS Latitude/Longitude	
				Start	End
Item	Vegetation			38.514899 °	38.514842 °
				-121.543224 °	-121.543444 °
DWR ID	DWR_MA0009_01_s_2012_70				
Comment Code					
V6 : Landscaping					
Inspector Comment					
The wall and wrought iron fence are unauthorized. Vegetation on fence blocks visibility.

View of the wall built along the levee toe on the landward side looking downstream. Landscape vegetation is starting to block the wall. Spring 2016.

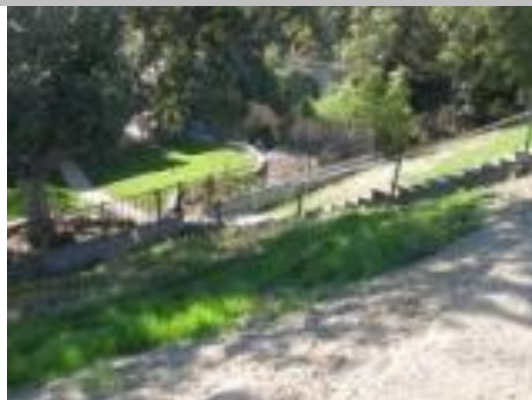
Photo 2 of 2 : FA\_2019\_MA0009\_201\_70\_20190904\_00028.jpg

Wall built along toe of levee. Fall 2012

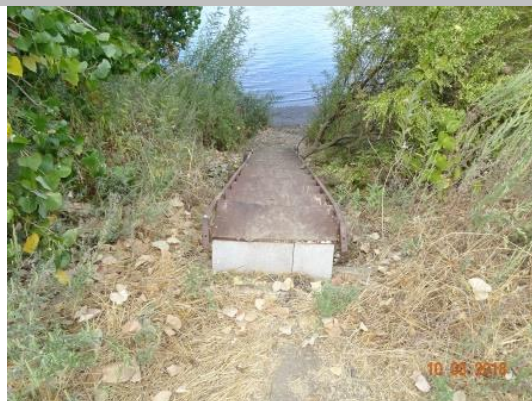
Photo 1 of 2 : FA\_2019\_MA0009\_201\_495\_20190904\_00289.jpg

View of metal stairway to water. Fall 2018

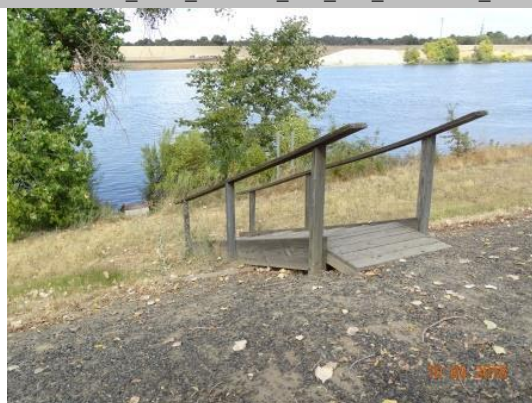
Photo 2 of 2 : FA\_2019\_MA0009\_201\_495\_20190904\_00290.jpg

View of wooden stairway on waterside slope. Fall 2018

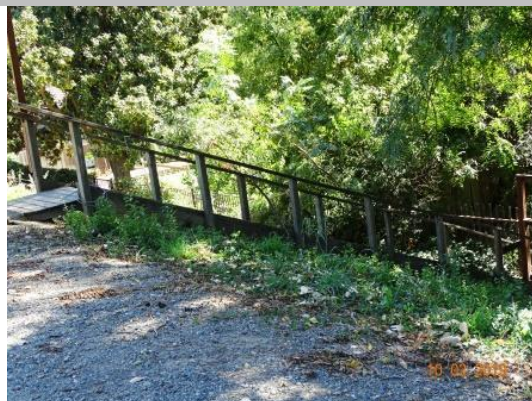
Photo 1 of 1 : FA\_2019\_MA0009\_201\_271\_20191008\_00516.jpg

View of wooden stairway with railings on the landside slope. Fall 2019

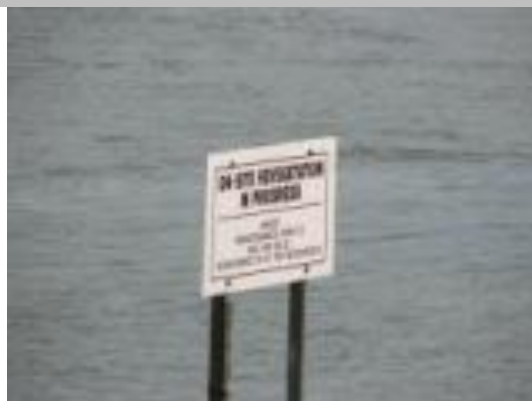
Photo 1 of 2 : FA\_2019\_MA0009\_201\_100\_20190904\_00042.jpg

LM Start	3.30	Rating **	A/W	Issue No.	100
LM End	3.52	Issue Type +	En	Location *	WS
Category	Earthen Levee			GPS Latitude/Longitude	
				Start	End
Item	Vegetation			38.514757 °	38.513647 °
				-121.543781 °	-121.547648 °
DWR ID	DWR_MA0009_01_s_2012_100				
Comment Code					
V8 : Environmental Requirements.					
Inspector Comment

A revegetation site. Photo taken spring 2012.

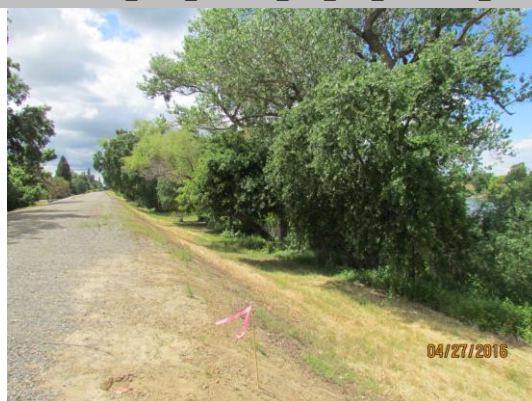
Photo 2 of 2 : FA\_2019\_MA0009\_201\_100\_20190904\_00043.jpg

View of the revegetation site on the berm of the waterward side of the levee looking downstream. Spring 2016.

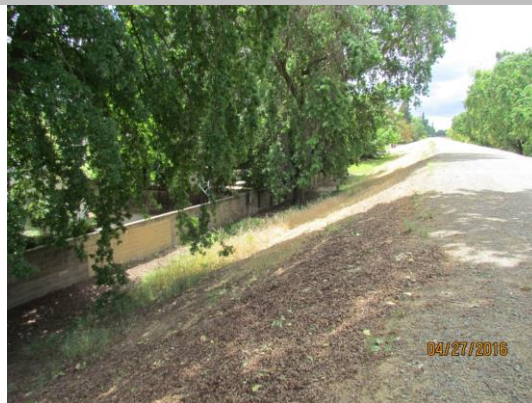
Photo 1 of 1 : FA\_2019\_MA0009\_201\_73\_20190904\_00030.jpg

LM Start	3.31	Rating **	U	Issue No.	73	
LM End	3.34	Issue Type +	En	Location *	LS	
Category	Earthen Levee			GPS Latitude/Longitude		
				Start		End
Item	Encroachments			38.514718 °		38.514555 °
				-121.543961 °		-121.544552 °
DWR ID	DWR_MA0009_01_s_2012_73					
Comment Code						
FE : Fence						
Inspector Comment						
The concrete/masonry wall fence does not appear to be authorized.

View of the wood and block fence at the toe of the levee on the landward side looking downstream. Spring 2016.

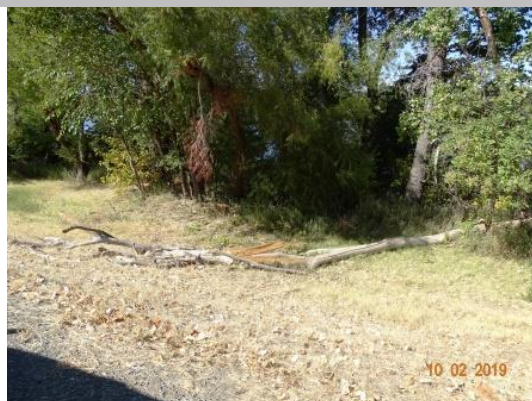
Photo 1 of 1 : FA\_2019\_MA0009\_201\_187\_20191008\_00517.jpg

View of fallen tree limb on the waterside slope. Fall 2019

LM Start	3.47	Rating **	M	Issue No.	187
LM End	3.47	Issue Type +	Ma	Location *	WS
Category	Earthen Levee			GPS Latitude/Longitude	
				Start	End
Item	Encroachments			38.513880 °	38.513880 °
				-121.546778 °	-121.546778 °
DWR ID	DWR_MA0009_01_f_2019_187				
Comment Code					
TR : Tree or limb					
Inspector Comment					
Remove fallen tree on waterside slope.

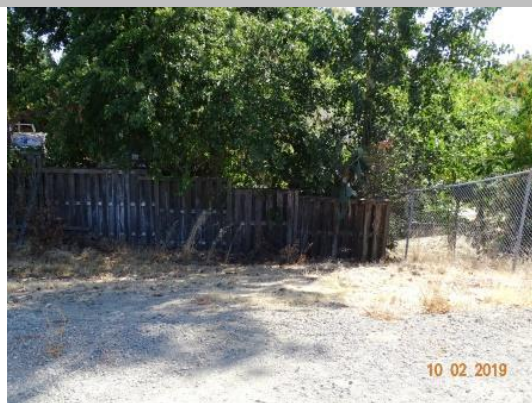
Photo 1 of 1 : FA\_2019\_MA0009\_201\_76\_20191008\_00518.jpg

LM Start	3.65	Rating **	M	Issue No.	76
LM End	3.65	Issue Type +	En	Location *	LS
Category	Earthen Levee			GPS Latitude/Longitude	
				Start	End
Item	Encroachments			38.513068 °	38.513068 °
				-121.549977 °	-121.549977 °
DWR ID	DWR_MA0009_01_f _ 2019_76				
Comment Code					
FE : Fence					
Inspector Comment					
The wooden fence alignment reaches the levee toe and does not appear to be authorized and is listed on the levee log. There is also a cactus at the toe.

View of wooden fence at levee toe. Fall 2019

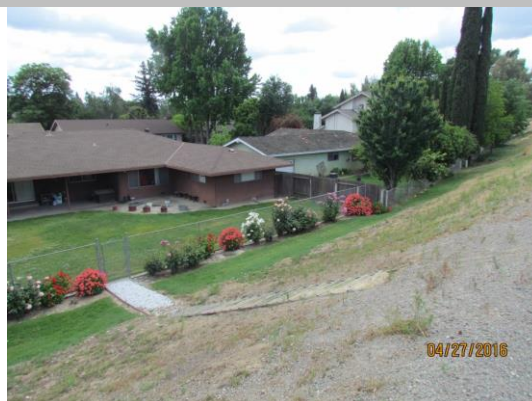
Photo 1 of 1 : FA\_2019\_MA0009\_201\_82\_20190904\_00034.jpg

LM Start	3.74	Rating **	M	Issue No.	82
LM End	3.74	Issue Type +	En	Location *	LS
Category	Earthen Levee			GPS Latitude/Longitude	
				Start	End
Item	Encroachments			38.512507 °	38.512507 °
				-121.551334 °	-121.551334 °
DWR ID	DWR_MA0009_01_s_2012_82				
Comment Code					
ST : Stairway					
Inspector Comment					
Steps are not permitted.

View of the steps and landscaping at the toe of the levee on the landward side looking downstream. Spring 2016.

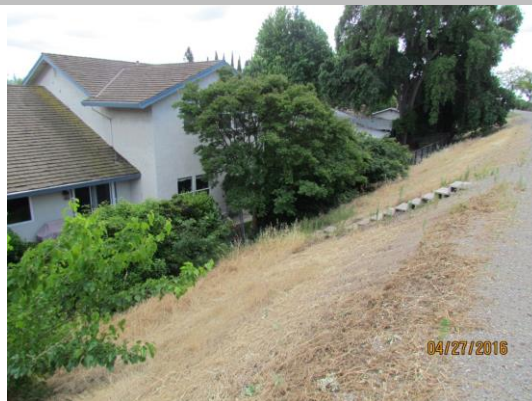
Photo 1 of 1 : FA\_2019\_MA0009\_201\_88\_20190904\_00037.jpg

LM Start	3.83	Rating **	U	Issue No.	88
LM End	3.83	Issue Type +	En	Location *	LS
Category	Earthen Levee			GPS Latitude/Longitude	
				Start	End
Item	Vegetation			38.511605 °	38.511605 °
				-121.552533 °	-121.552533 °
DWR ID	DWR_MA0009_01_s_2012_88				
Comment Code					
V6 : Landscaping					
Inspector Comment					
Vegetation is on the fence and blocks visibility.

View of the landscaping at the toe of the levee on the landward side of the levee looking downstream. Spring 2016.

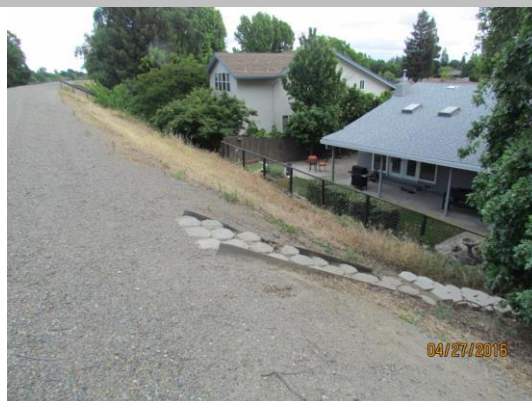
Photo 1 of 1 : FA\_2019\_MA0009\_201\_89\_20190904\_00038.jpg

LM Start	3.85	Rating **	M	Issue No.	89
LM End	3.85	Issue Type +	En	Location *	LS
Category	Earthen Levee			GPS Latitude/Longitude	
				Start	End
Item	Encroachments			38.511372 °	38.511372 °
				-121.552767 °	-121.552767 °
DWR ID	DWR_MA0009_01_s_2012_89				
Comment Code					
ST : Stairway					
Inspector Comment					
Concrete stairs are not authorized.

View of the steps on the landward side of the levee looking upstream.  
Spring 2016.

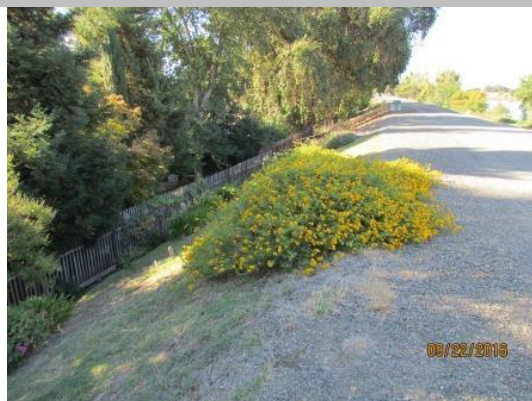
Photo 2 of 2 : FA\_2019\_MA0009\_201\_246\_20190904\_00170.jpg

LM Start	3.94	Rating **	M	Issue No.	246 (cont)	
LM End	3.94	Issue Type +	En	Location *	LS	
Category	Earthen Levee			GPS Latitude/Longitude		
				Start		End
Item	Vegetation			38.510207 °		38.510207 °
				-121.553730 °		-121.553730 °
DWR ID	DWR_MA0009_01_f_2016_246					
Comment Code						
V6 : Landscaping						
Inspector Comment						
Groundover blocks visibility of the landside slope.

View of vegetation on LS slope and crown. Fall 2016.

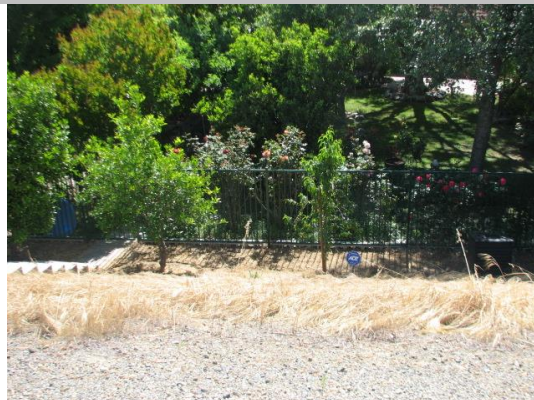
Photo 1 of 2 : FA\_2019\_MA0009\_201\_97\_20190904\_00040.jpg

New fruit trees have been added to the toe of the levee. Spring 2014

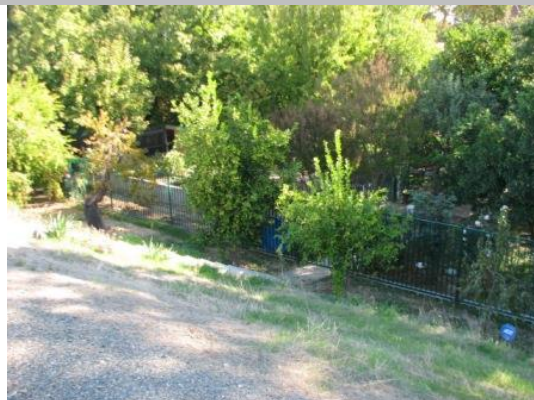
Photo 2 of 2 : FA\_2019\_MA0009\_201\_97\_20190904\_00041.jpg

Fruit trees and landscaping within the easement. Fall 2013

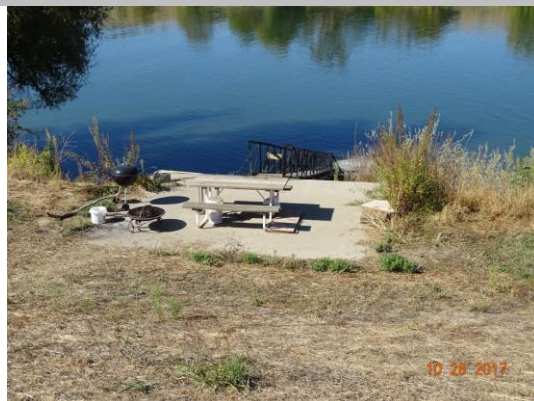
Photo 1 of 1 : FA\_2019\_MA0009\_201\_392\_20190904\_00274.jpg

View of encroachments on waterside slope. Fall 2017.

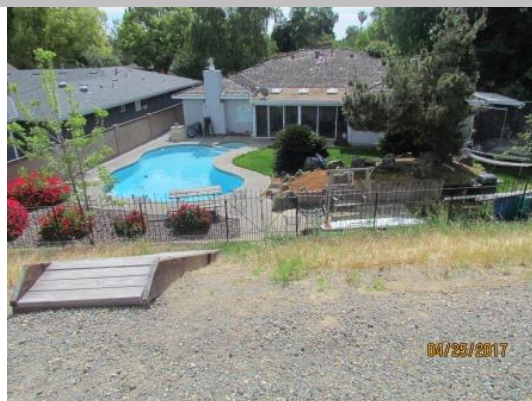
Photo 1 of 1 : FA\_2019\_MA0009\_201\_105\_20190904\_00045.jpg

LM Start	4.06	Rating **	M	Issue No.	105
LM End	4.06	Issue Type +	En	Location *	LS
Category	Earthen Levee			GPS Latitude/Longitude	
				Start	End
Item	Encroachments			38.508666 °	38.508666 °
				-121.554584 °	-121.554584 °
DWR ID	DWR_MA0009_01_s_2012_105				
Comment Code					
ST : Stairway					
Inspector Comment					
Steps, fence, and pool do not appear to be permitted.

View of steps, fence and landscape. Spring 2017

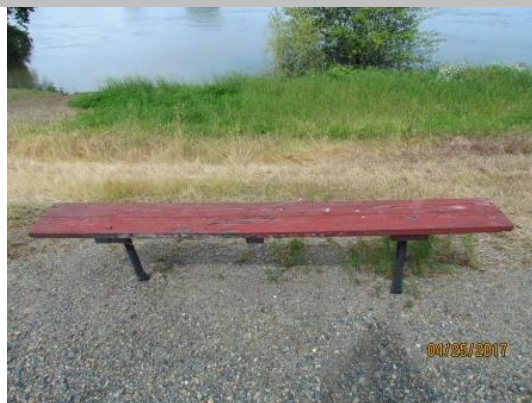
Photo 1 of 1 : FA\_2019\_MA0009\_201\_274\_20190904\_00193.jpg

LM Start	4.09	Rating **	M	Issue No.	274
LM End	4.09	Issue Type +	En	Location *	WS
Category	Earthen Levee			GPS Latitude/Longitude	
				Start	End
Item	Encroachments			38.508315 °	38.508315 °
				-121.554740 °	-121.554740 °
DWR ID	DWR_MA0009_01_s_2017_274				
Comment Code					
DE : Debris					
Inspector Comment					
Bench on waterside shoulder.

View of bench on waterside shoulder. Spring 2017.

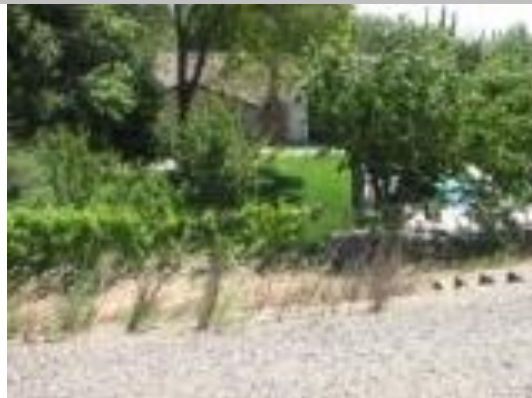
Photo 1 of 1 : FA\_2019\_MA0009\_201\_195\_20190904\_00122.jpg

LM Start	4.10	Rating **	M	Issue No.	195
LM End	4.10	Issue Type +	En	Location *	LS
Category	Earthen Levee			GPS Latitude/Longitude	
				Start	End
Item	Vegetation			38.508166 °	38.508166 °
				-121.554827 °	-121.554827 °
DWR ID	DWR_MA0009_01_s_2018_195				
Comment Code					
V6 : Landscaping					
Inspector Comment					
Vines on fence obstruct visibility.

Fence with grape vines growing on it. Spring 2013

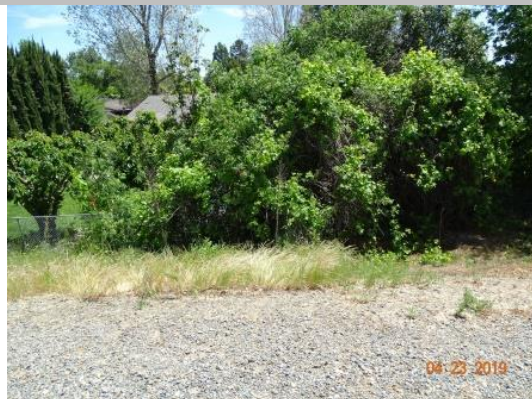
Photo 1 of 1 : FA\_2019\_MA0009\_201\_530\_20190904\_00293.jpg

LM Start	4.11	Rating **	M	Issue No.	530
LM End	4.11	Issue Type +	En	Location *	LS
Category	Earthen Levee			GPS Latitude/Longitude	
				Start	End
Item	Vegetation			38.507970 °	38.507970 °
				-121.554935 °	-121.554935 °
DWR ID	DWR_MA0009_01_s_2019_530				
Comment Code					
V6 : Landscaping					
Inspector Comment					
Trim and thin trees for visibility of levee toe.

View of landscaping that blocks visibility of landside toe. Spring 2019

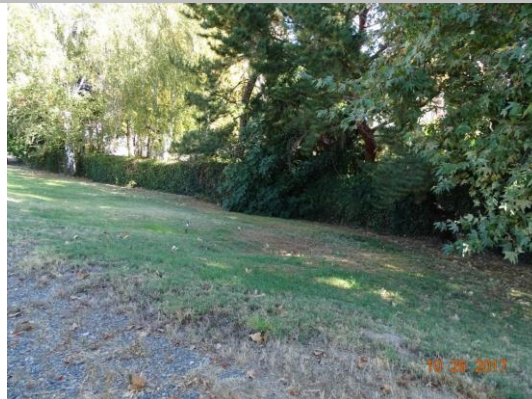
Photo 1 of 1 : FA\_2019\_MA0009\_201\_396\_20190904\_00275.jpg

LM Start	4.20	Rating **	U	Issue No.	396
LM End	4.22	Issue Type +	En	Location *	LS
Category	Earthen Levee			GPS Latitude/Longitude	
				Start	End
Item	Vegetation			38.506850 °	38.506568 °
				-121.555607 °	-121.555693 °
DWR ID	DWR_MA0009_01_f_2018_396				
Comment Code					
V6 : Landscaping					
Inspector Comment					
Vegetation on chain link fence blocks visibility.

View of vegetation on fence on landside. Fall 2017.

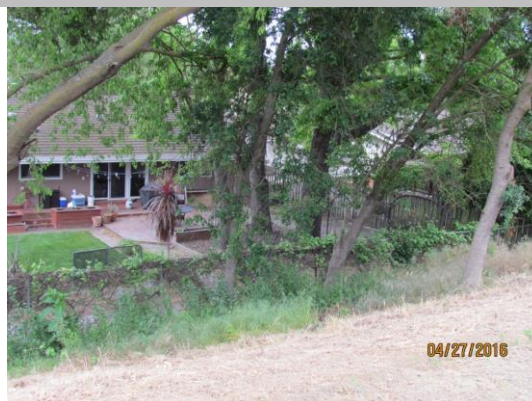
Photo 1 of 2 : FA\_2019\_MA0009\_201\_335\_20190904\_00238.jpg

View of the vegetation on the landward side of the levee. Wild grapes have been cleared but there still seems to be vines on the fence. Spring 2016.

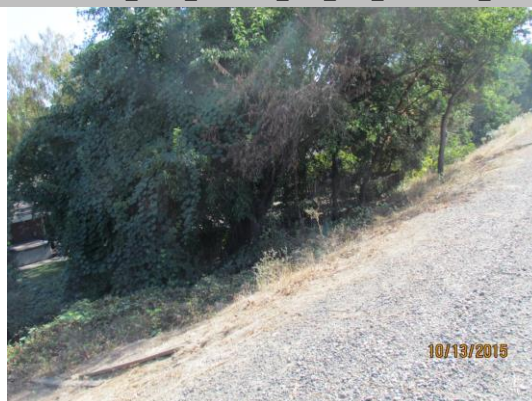
Photo 2 of 2 : FA\_2019\_MA0009\_201\_335\_20190904\_00239.jpg

View of the vegetation on the landward side of the levee looking downstream. Fall 2015.

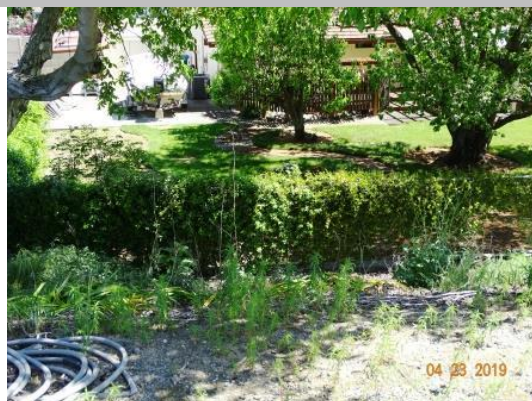
Photo 1 of 1 : FA\_2019\_MA0009\_201\_534\_20190904\_00295.jpg

LM Start	4.34	Rating **	M	Issue No.	534
LM End	4.34	Issue Type +	En	Location *	LS
Category	Earthen Levee			GPS Latitude/Longitude	
				Start	End
Item	Vegetation			38.504785 °	38.504785 °
				-121.556322 °	-121.556322 °
DWR ID	DWR_MA0009_01_s_2019_534				
Comment Code					
V6 : Landscaping					
Inspector Comment					
Vines on chainlink fence block visibility.

View of vines on chainlink fence that block visibility of levee toe easement. Spring 2019

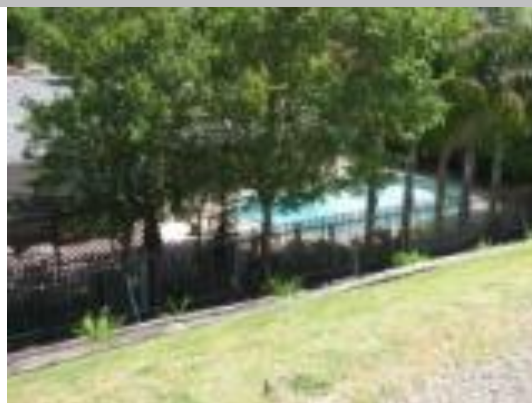
Photo 1 of 1 : FA\_2019\_MA0009\_201\_121\_20190904\_00052.jpg

LM Start	4.45	Rating **	M	Issue No.	121
LM End	4.45	Issue Type +	En	Location *	LS
Category	Earthen Levee			GPS Latitude/Longitude	
				Start	End
Item	Encroachments			38.503350 °	38.503350 °
				-121.556800 °	-121.556800 °
DWR ID	DWR_MA0009_01_s_2012_121				
Comment Code					
RW : Retaining Wall					
Inspector Comment

The levee slope has been terraced and with a small retaining wall, fence and landscape. Spring 2013

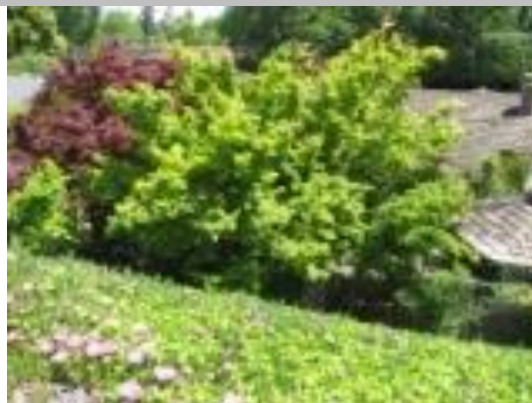
Photo 1 of 1 : FA\_2019\_MA0009\_201\_122\_20190904\_00053.jpg

LM Start	4.46	Rating **	M	Issue No.	122
LM End	4.46	Issue Type +	En	Location *	LS
Category	Earthen Levee			GPS Latitude/Longitude	
				Start	End
Item	Vegetation			38.503106 °	38.503106 °
				-121.556917 °	-121.556917 °
DWR ID	DWR_MA0009_01_s_2019_122				
Comment Code					
V6 : Landscaping					
Inspector Comment					
Maple trees are not permitted on the slope.

Groundcover, fence and landscape makes it hard to see the toe. Spring 2013

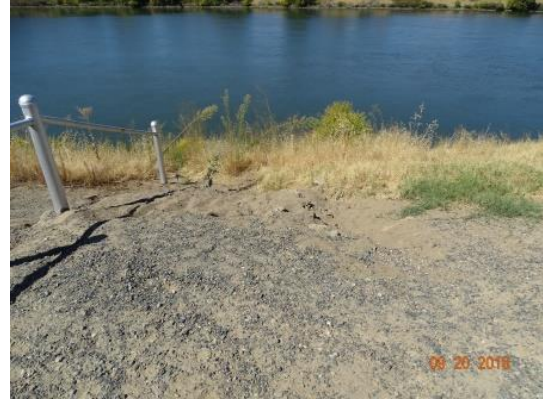
Photo 1 of 3 : FA\_2019\_MA0009\_201\_333\_20190904\_00234.jpg

LM Start	4.59	Rating **	M	Issue No.	333
LM End	4.59	Issue Type +	Ma	Location *	WS
Category	Earthen Levee			GPS Latitude/Longitude	
				Start	End
Item	Erosion / Bank Caving			38.501356°	38.501356°
				-121.557638°	-121.557638°
DWR ID	DWR_MA0009_01_s_2016_333				
Comment Code					
E2 : Schedule repair of erosion site prior to the next inspection.					
Inspector Comment

View of erosion upstream of gate. Fall 2018

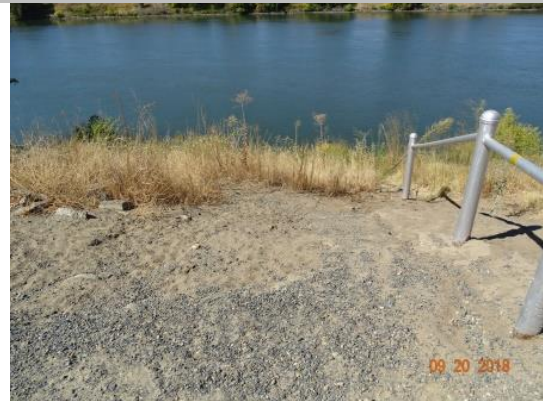
Photo 2 of 3 : FA\_2019\_MA0009\_201\_333\_20190904\_00235.jpg

View of erosion downstream of gate. Fall 2018

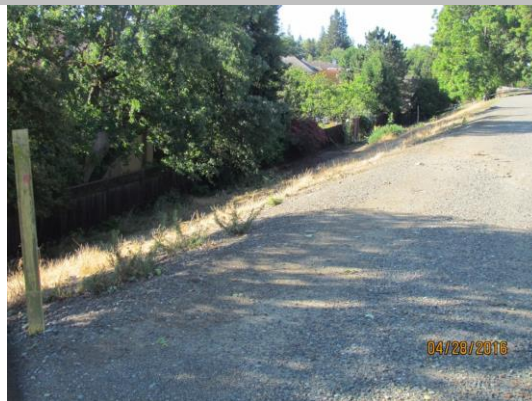
Photo 1 of 1 : FA\_2019\_MA0009\_201\_130\_20190904\_00057.jpg

LM Start	4.65	Rating **	M	Issue No.	130
LM End	4.70	Issue Type +	En	Location *	LS
Category	Earthen Levee			GPS Latitude/Longitude	
				Start	End
Item	Encroachments			38.500565 °	38.499761 °
				-121.557810 °	-121.557832 °
DWR ID	DWR_MA0009_01_s _ 2012_130				
Comment Code					
FE : Fence					
Inspector Comment					
The solid, wooden fence does not meet Permit 16400 requirements for a see-through fence.

View of the wooden fence under the trees at the toe of the levee on the landward side looking downstream. Spring 2016.

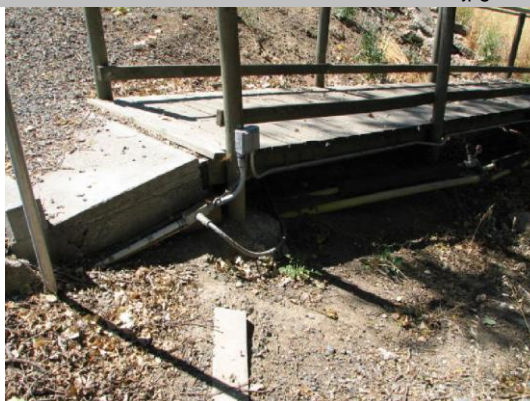
Photo 1 of 3 : UCIP\_FA\_2019\_5760\_8723.jpg

LM Start	4.65	Rating **	M	Issue No.	1790
LM End	4.65	Issue Type +	En	Location *	
Category	Supplemental			GPS Latitude/Longitude	
				Start	End
Item	DRAFT DWR UCIP Field Study			38.500490 °	38.500490 °
				-121.557780 °	-121.557780 °
DWR ID	17418				
Comment Code					
Inspector Comment					
DS_ID:17418 FS_ID:5760 EP_NO: N/A Repair Type: Non-Urgent Crossing Status: Indicator Found UCIP Comments: Locate and determine type of pipe abandonment. FIELD_STRUCT_DESC: *ABANDONED* 8-inch pipe through the levee, 3.4-feet below the crown. Constructed with 1-CM cut-off wall and a pump on the river side. Originally included in the O+M manual (1955). Levee log indicates this pipe abandoned in place. Two t-posts on LS toe may indicate location of pipe. Pictures in Permit 6525 clearly show this pipe just upstream of boat dock walkway. FS Date: 7/25/2012 9:10:00 AM

Boat dock ramp on WS shoulder where pipe may have come through.

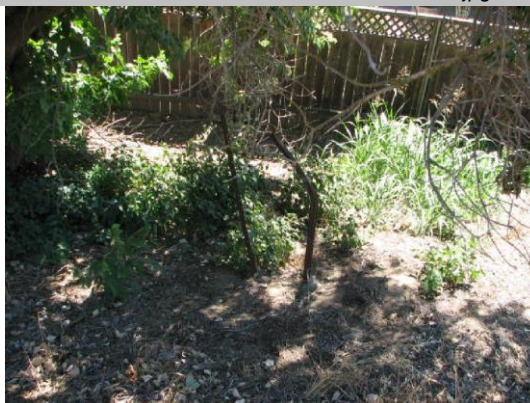
Photo 2 of 3 : UCIP\_FA\_2019\_5760\_8722.jpg

Two t-posts may indicate pipe location on LS slope.

LM Start	4.65	Rating **	M	Issue No.	1790 (cont)
LM End	4.65	Issue Type +	En	Location *	
Category	Supplemental			GPS Latitude/Longitude	
				Start	End
Item	DRAFT DWR UCIP Field Study			38.500490 °	38.500490 °
				-121.557780 °	-121.557780 °
DWR ID	17418				
Comment Code					
Inspector Comment					
DS_ID:17418 FS_ID:5760 EP_NO: N/A Repair Type: Non-Urgent Crossing Status: Indicator Found UCIP Comments: Locate and determine type of pipe abandonment. FIELD_STRUCT_DESC: *ABANDONED* 8-inch pipe through the levee, 3.4-feet below the crown. Constructed with 1-CM cut-off wall and a pump on the river side. Originally included in the O+M manual (1955). Levee log indicates this pipe abandoned in place. Two t-posts on LS toe may indicate location of pipe. Pictures in Permit 6525 clearly show this pipe just upstream of boat dock walkway. FS Date: 7/25/2012 9:10:00 AM

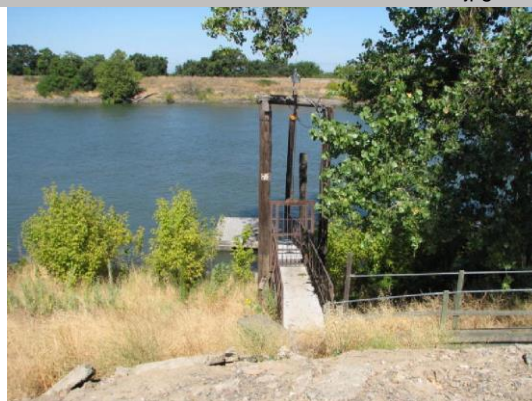
Photo 3 of 3 : UCIP\_FA\_2019\_5760\_8724.jpg

Pier and floating dock near location of pipe.

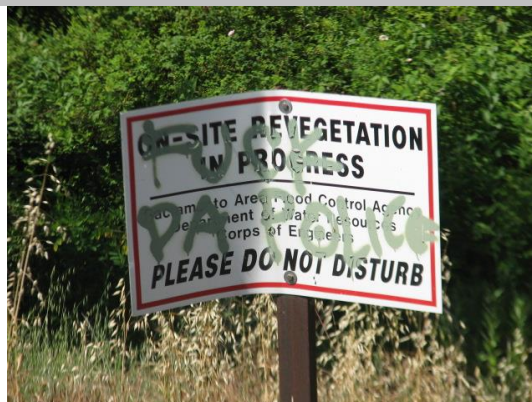
Photo 1 of 1 : FA\_2019\_MA0009\_201\_144\_20190904\_00071.jpg

LM Start	4.67	Rating **	A/W	Issue No.	144
LM End	4.78	Issue Type +	Ob	Location *	WS
Category	Earthen Levee			GPS Latitude/Longitude	
				Start	End
Item	Vegetation			38.500296°	38.498700°
				-121.557817°	-121.557832°
DWR ID	DWR_MA0009_01_s_2016_144				
Comment Code					
V8 : Environmental Requirements.					
Inspector Comment

Revegetation area on the waterside berm. Spring 2014

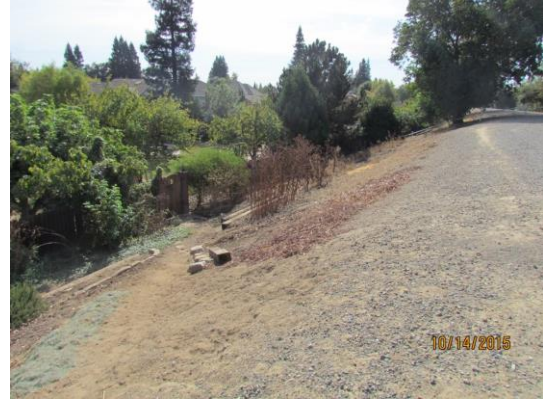
Photo 1 of 2 : FA\_2019\_MA0009\_201\_113\_20190904\_00047.jpg

LM Start	4.68	Rating **	M	Issue No.	113
LM End	4.68	Issue Type +	En	Location *	LS
Category	Earthen Levee			GPS Latitude/Longitude	
				Start	End
Item	Vegetation			38.500062 °	38.500062 °
				-121.557825 °	-121.557825 °
DWR ID	DWR_MA0009_01_s_2012_113				
Comment Code					
V6 : Landscaping					
Inspector Comment					
Vegetation has been sprayed but still needs to be cleared.

View of the landscaping on the landward side of the levee looking downstream. Fall 2015.

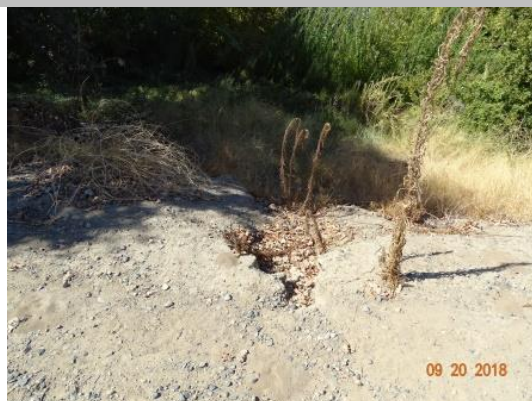
Photo 1 of 2 : FA\_2019\_MA0009\_201\_234\_20190904\_00152.jpg

Notes: This site was visited but no data was recorded at the time. The Sac Yard is planning on repairing this site. Damage looks like it may have been caused by a nearby resident draining a pool with a hose. 2019 Spring DWR Inspection: Wood chips have been placed on erosion sites.

View of erosion on waterside slope. Fall 2018

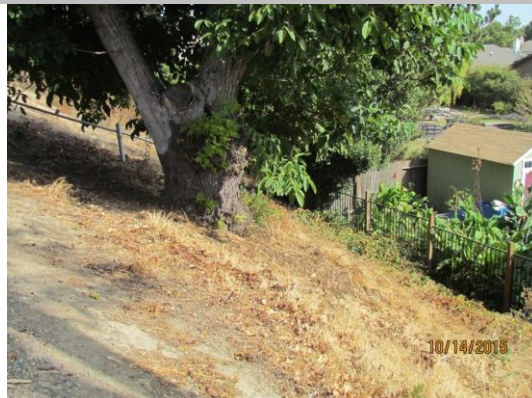
Photo 1 of 1 : FA\_2019\_MA0009\_201\_131\_20190904\_00058.jpg

LM Start	4.71	Rating **	M	Issue No.	131
LM End	4.71	Issue Type +	En	Location *	LS
Category	Earthen Levee			GPS Latitude/Longitude	
				Start	End
Item	Vegetation			38.499636 °	38.499636 °
				-121.557871 °	-121.557871 °
DWR ID	DWR_MA0009_01_s_2012_131				
Comment Code					
V6 : Landscaping					
Inspector Comment

View of the landscaping on the landward side of the levee looking upstream. Blackberry shrubs are at the toe of the levee. Fall 2015.

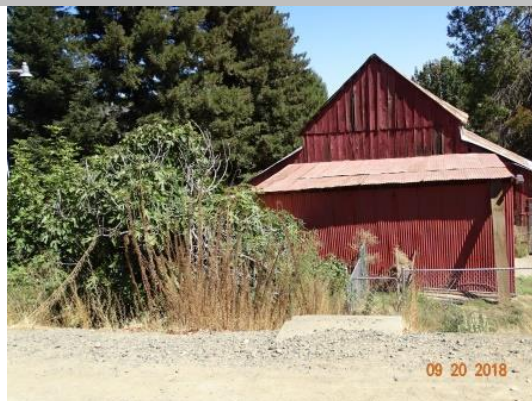
Photo 1 of 1 : FA\_2019\_MA0009\_201\_411\_20190904\_00277.jpg

LM Start	4.95	Rating **	M	Issue No.	411
LM End	4.98	Issue Type +	En	Location *	LS
Category	Earthen Levee			GPS Latitude/Longitude	
				Start	End
Item	Encroachments			38.496184 °	38.495824 °
				-121.557039 °	-121.556820 °
DWR ID	DWR_MA0009_01_f_2017_411				
Comment Code					
FE : Fence					
Inspector Comment					
Chain link fence at landside toe appears to be unauthorized.

View of fence, stairway, and vegetation encroaching levee slope. Fall 2018

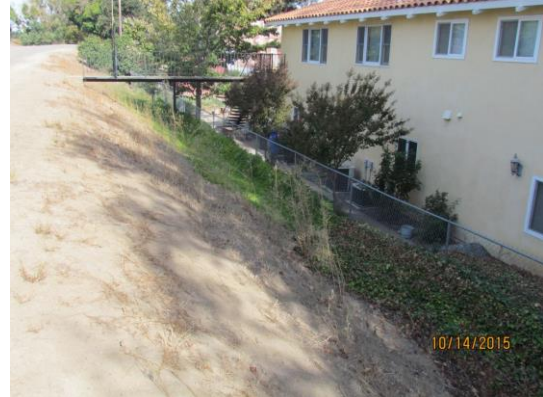
Photo 1 of 2 : FA\_2019\_MA0009\_201\_135\_20190904\_00063.jpg

LM Start	4.96	Rating **	M	Issue No.	135
LM End	4.98	Issue Type +	En	Location *	LS
Category	Earthen Levee			GPS Latitude/Longitude	
				Start	End
Item	Encroachments			38.496110°	38.495871°
				-121.556939°	-121.556777°
DWR ID	DWR_MA0009_01_s_2012_135				
Comment Code					
RW : Retaining Wall					
Inspector Comment

View of the landscaping on the landward side of the levee looking upstream. The retaining wall has been covered by the groundcover. Fall 2015.

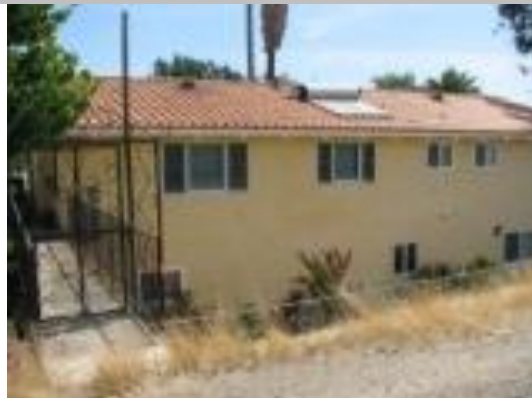
Photo 1 of 1 : FA\_2019\_MA0009\_201\_136\_20190904\_00065.jpg

LM Start	4.97	Rating **	M	Issue No.	136
LM End	4.97	Issue Type +	En	Location *	LS
Category	Earthen Levee			GPS Latitude/Longitude	
				Start	End
Item	Encroachments			38.495981 °	38.495981 °
				-121.556864 °	-121.556864 °
DWR ID	DWR_MA0009_01_s _ 2012_136				
Comment Code					
BU : Building					
Inspector Comment

The two story house was built at the toe of the levee.

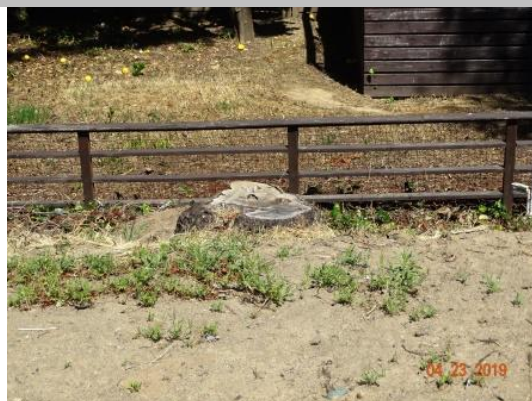
Photo 1 of 1 : FA\_2019\_MA0009\_201\_542\_20190904\_00296.jpg

LM Start	4.99	Rating **	N	Issue No.	542
LM End	4.99	Issue Type +	Ma	Location *	LS
Category	Earthen Levee			GPS Latitude/Longitude	
				Start	End
Item	Trim / Thin Trees			38.495745 °	38.495745 °
				-121.556683 °	-121.556683 °
DWR ID	DWR_MA0009_01_s _ 2019_542				
Comment Code					
T5 : Tree stumps.					
Inspector Comment

View of tree stump at levee toe. Spring 2019

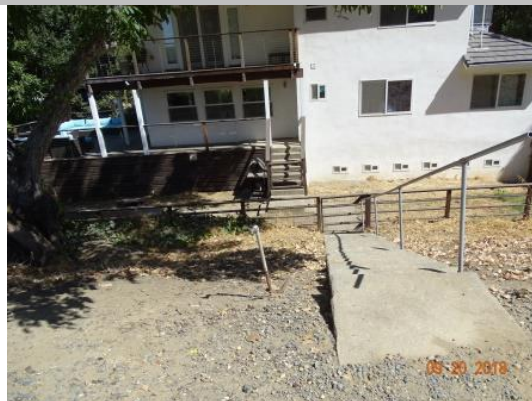
Photo 1 of 2 : FA\_2019\_MA0009\_201\_138\_20190904\_00066.jpg

LM Start	4.99	Rating **	M	Issue No.	138
LM End	4.99	Issue Type +	En	Location *	LS
Category	Earthen Levee			GPS Latitude/Longitude	
				Start	End
Item	Encroachments			38.495687 °	38.495687 °
				-121.556705 °	-121.556705 °
DWR ID	DWR_MA0009_01_s _ 2012_138				
Comment Code					
BU : Building					
Inspector Comment					
Building and hose bib on landside slope.

View of house at landside toe and stairway and hose bib on levee slope.  
Fall 2018**\* Location**

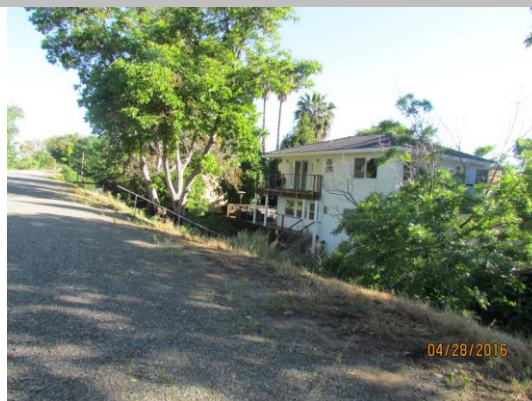
Photo 2 of 2 : FA\_2019\_MA0009\_201\_138\_20190904\_00067.jpg

LM Start	4.99	Rating **	M	Issue No.	138 (cont)	
LM End	4.99	Issue Type +	En	Location *	LS	
Category	Earthen Levee			GPS Latitude/Longitude		
				Start	End	
Item	Encroachments			38.495687 °	38.495687 °	
				-121.556705 °	-121.556705 °	
DWR ID	DWR_MA0009_01_s_2012_138					
Comment Code						
BU : Building						
Inspector Comment						
Building and hose bib on landside slope.

View of the house at the toe of the levee on the landward side looking upstream. Spring 2016.

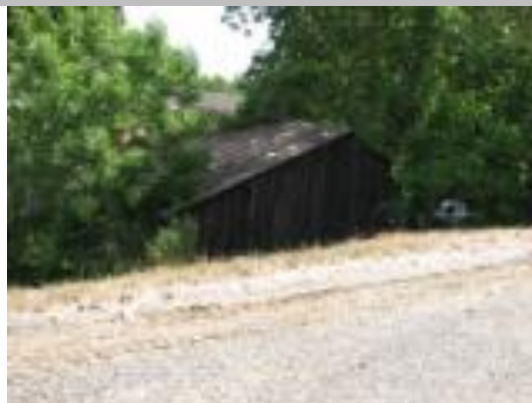
Photo 1 of 2 : FA\_2019\_MA0009\_201\_139\_20190904\_00068.jpg

LM Start	5.01	Rating **	U	Issue No.	139
LM End	5.01	Issue Type +	En	Location *	LS
Category	Earthen Levee			GPS Latitude/Longitude	
				Start	End
Item	Encroachments			38.495529 °	38.495529 °
				-121.556592 °	-121.556592 °
DWR ID	DWR_MA0009_01_s_2012_139				
Comment Code					
BU : Building					
Inspector Comment

The side of the barn is into levee toe.
